## FOTO SURVEY KONDISI JALAN TAHUN 2025

**RUAS JALAN : Karanggayam - Nologaten**

| NO. RUAS | NAMA RUAS | DPU Kab. Sleman | PETUGAS SURVEY | HALAMAN |
| 35 | Karanggayam - Nologaten | | | 1 |

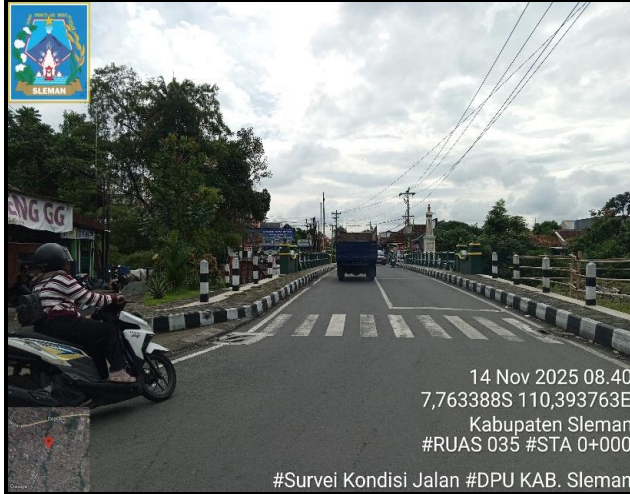
LOKASI :           **STA           0+000**

KONDISI PERKERASAN :       Baik  
LEBAR PERKERASAN :       12           M  
TYPE PERKERASAN :       Aspal

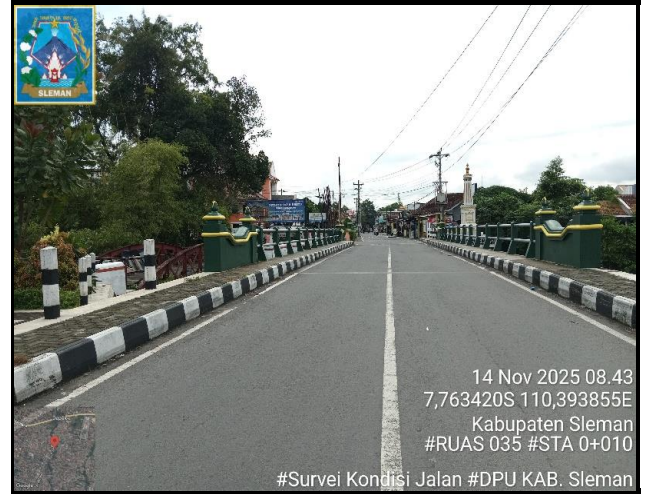
LOKASI :           **STA           0+010**

KONDISI PERKERASAN :       Baik  
LEBAR PERKERASAN :       6           M  
TYPE PERKERASAN :       Aspal

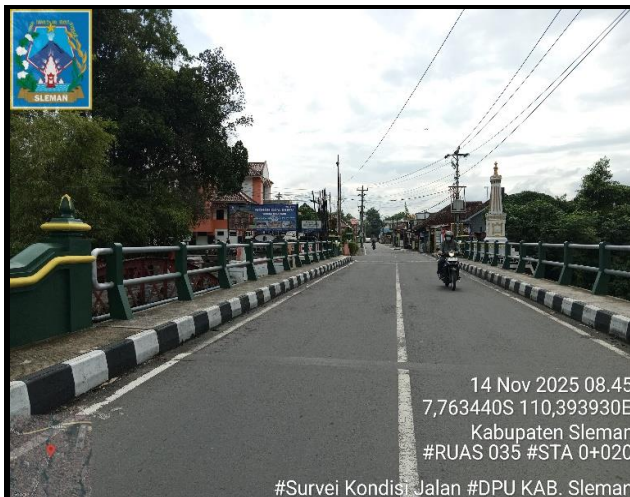
LOKASI :           **STA           0+020**

KONDISI PERKERASAN :       Baik  
LEBAR PERKERASAN :       6           M  
TYPE PERKERASAN :       Aspal

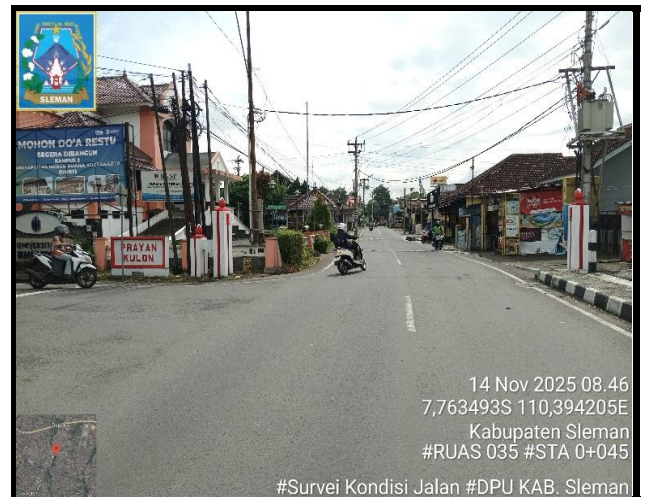
LOKASI :           **STA           0+045**

KONDISI PERKERASAN :       Baik  
LEBAR PERKERASAN :       5,8          M  
TYPE PERKERASAN :       Aspal

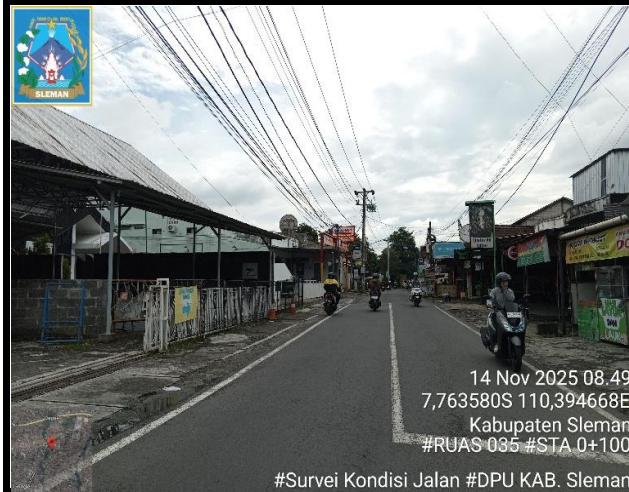
LOKASI :                **STA**                **0+100**

KONDISI PERKERASAN :        Baik  
LEBAR PERKERASAN :        5,8                M  
TYPE PERKERASAN :        Aspal

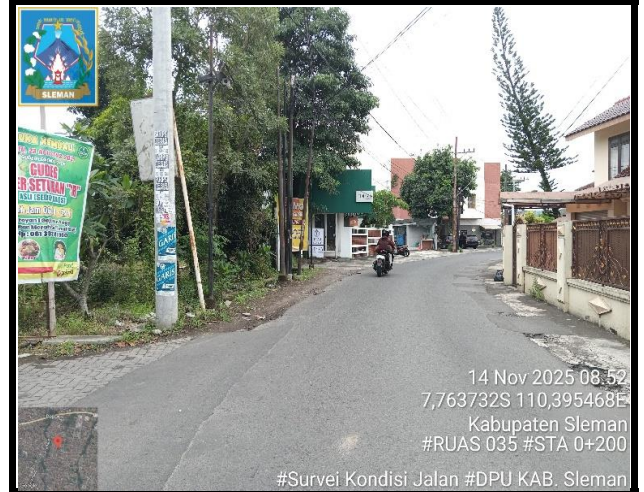
LOKASI :                **STA**                **0+200**

KONDISI PERKERASAN :        Sedang  
LEBAR PERKERASAN :        4,8                M  
TYPE PERKERASAN :        Aspal

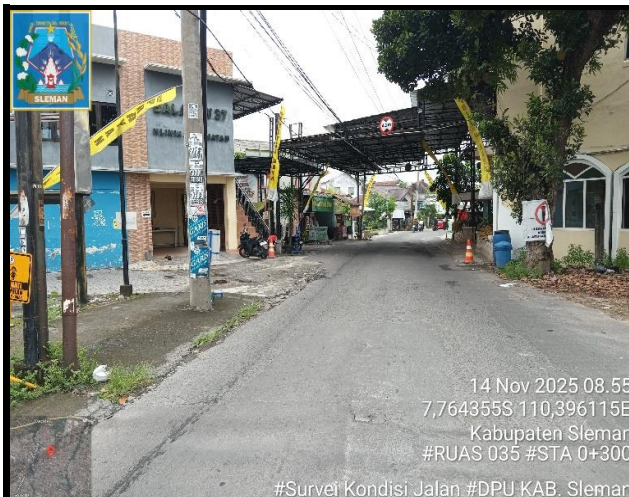
LOKASI :                **STA**                **0+300**

KONDISI PERKERASAN :        Sedang  
LEBAR PERKERASAN :        4,8                M  
TYPE PERKERASAN :        Aspal

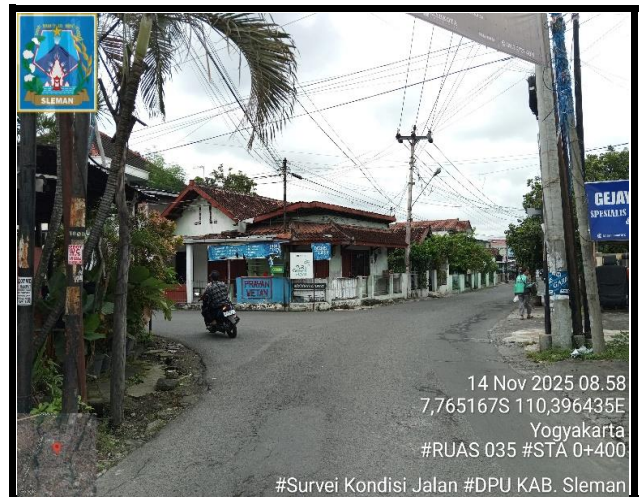
LOKASI :                **STA**                **0+400**

KONDISI PERKERASAN :        Sedang  
LEBAR PERKERASAN :        4,8                M  
TYPE PERKERASAN :        Aspal

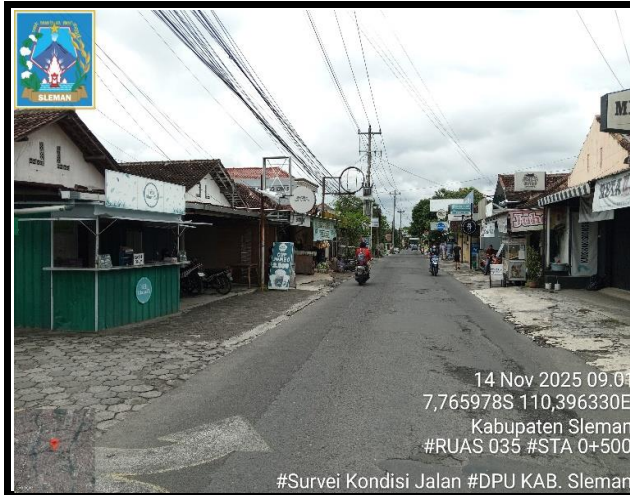
LOKASI :               **STA               0+500**

KONDISI PERKERASAN               :       Rusak Ringan  
LEBAR PERKERASAN               :       4,8               M  
TYPE PERKERASAN               :       Aspal

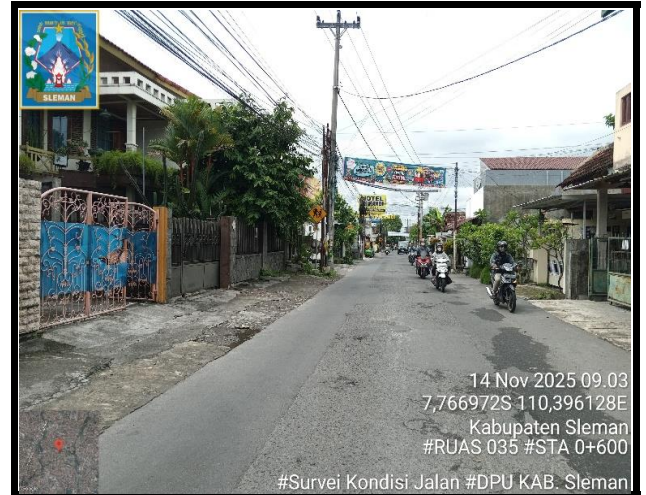
LOKASI :               **STA               0+600**

KONDISI PERKERASAN               :       Rusak Ringan  
LEBAR PERKERASAN               :       4,8               M  
TYPE PERKERASAN               :       Aspal

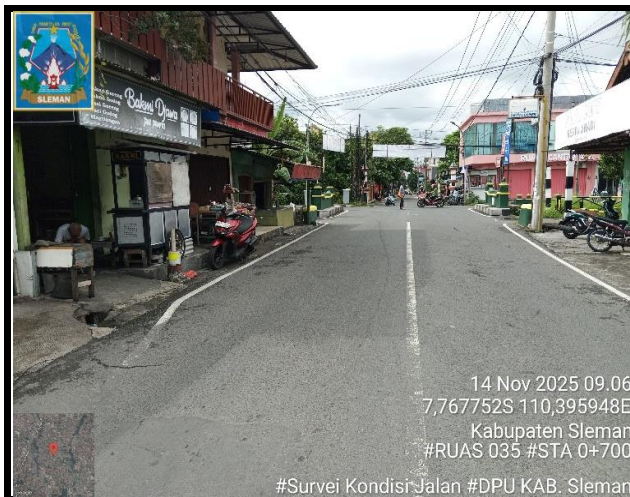
LOKASI :               **STA               0+700**

KONDISI PERKERASAN               :       Baik  
LEBAR PERKERASAN               :       5,8               M  
TYPE PERKERASAN               :       Aspal

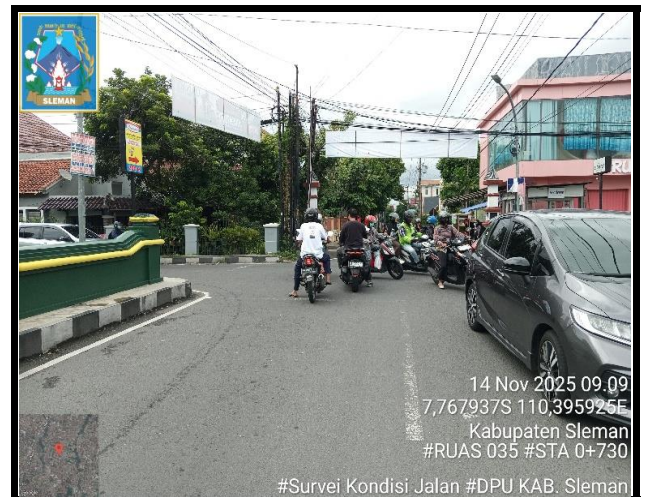
LOKASI :               **STA               0+730**

KONDISI PERKERASAN               :       Baik  
LEBAR PERKERASAN               :       8,2               M  
TYPE PERKERASAN               :       Aspal

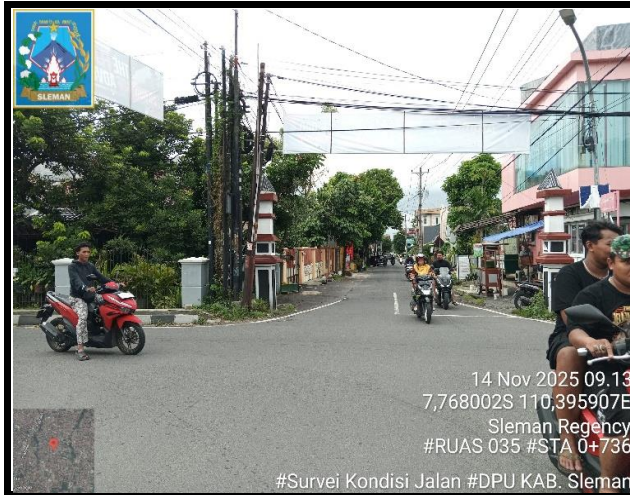
LOKASI : **STA 0+736**

KONDISI PERKERASAN : Baik  
LEBAR PERKERASAN : 4 M  
TYPE PERKERASAN : Aspal

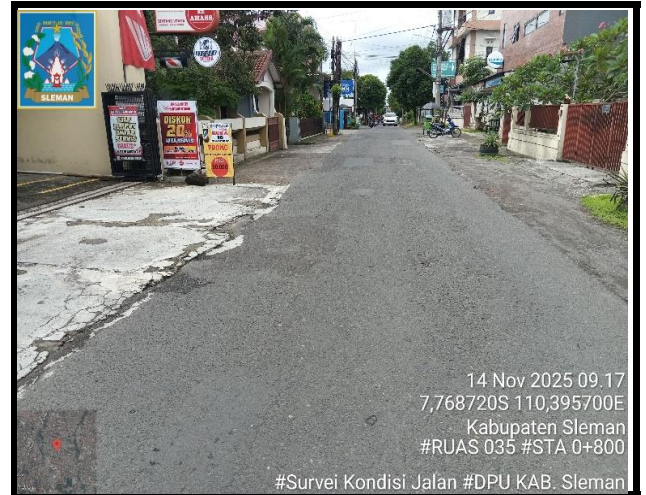
LOKASI : **STA 0+800**

KONDISI PERKERASAN : Sedang  
LEBAR PERKERASAN : 4 M  
TYPE PERKERASAN : Aspal

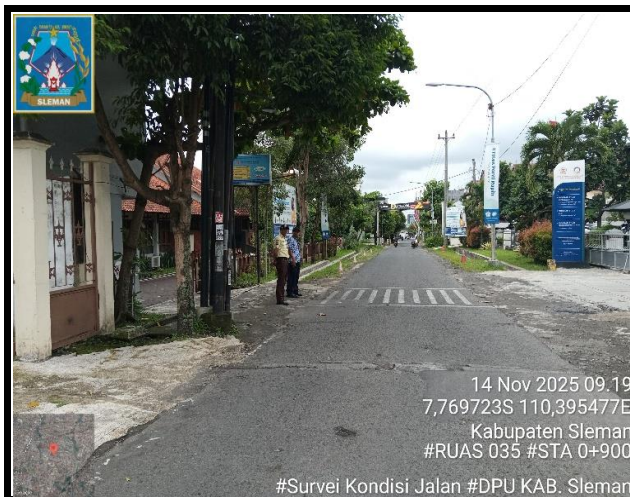
LOKASI : **STA 0+900**

KONDISI PERKERASAN : Sedang  
LEBAR PERKERASAN : 4 M  
TYPE PERKERASAN : Aspal

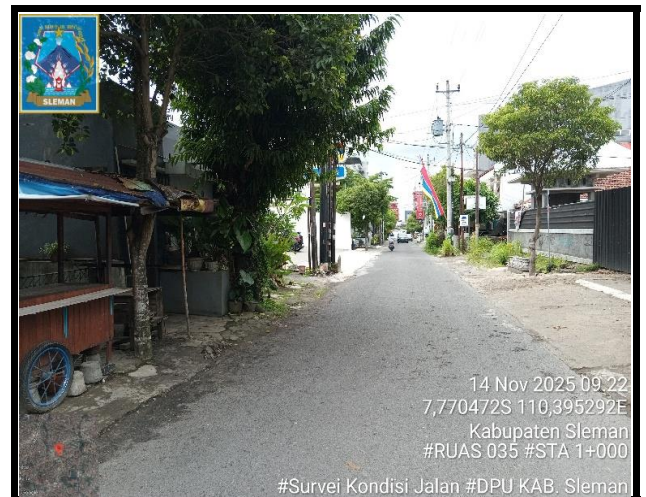
LOKASI : **STA 1+000**

KONDISI PERKERASAN : Sedang  
LEBAR PERKERASAN : 4 M  
TYPE PERKERASAN : Aspal

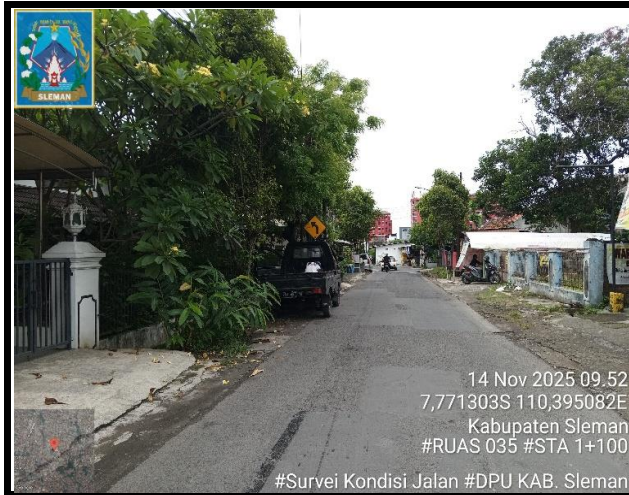
LOKASI :           **STA**                   **1+100**

KONDISI PERKERASAN :           **Sedang**  
LEBAR PERKERASAN :           4                   M  
TYPE PERKERASAN :           Aspal

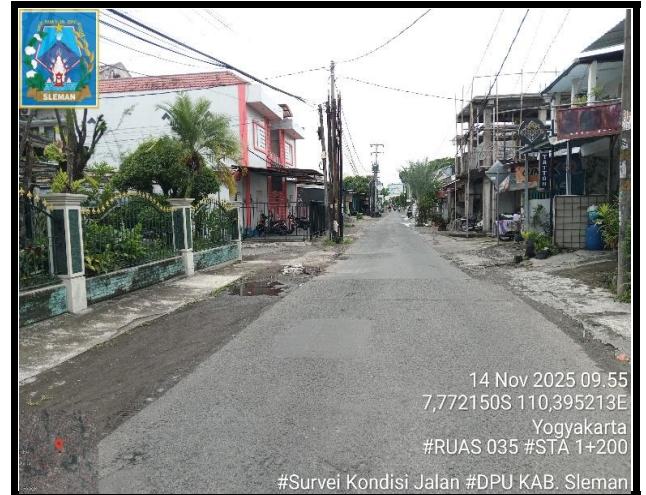
LOKASI :           **STA**                   **1+200**

KONDISI PERKERASAN :           **Sedang**  
LEBAR PERKERASAN :           4                   M  
TYPE PERKERASAN :           Aspal

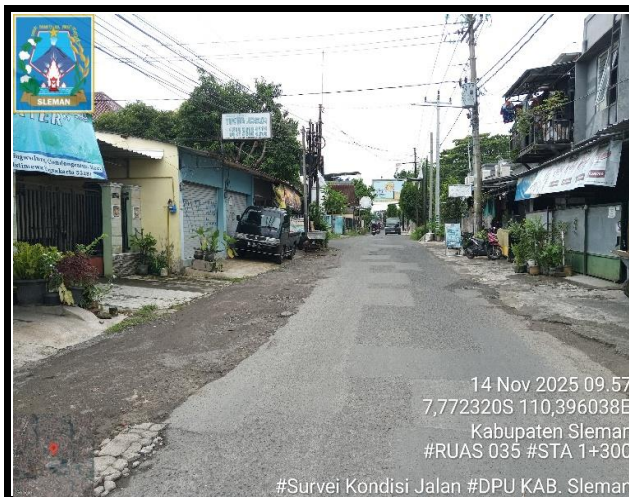
LOKASI :           **STA**                   **1+300**

KONDISI PERKERASAN :           **Sedang**  
LEBAR PERKERASAN :           4                   M  
TYPE PERKERASAN :           Aspal

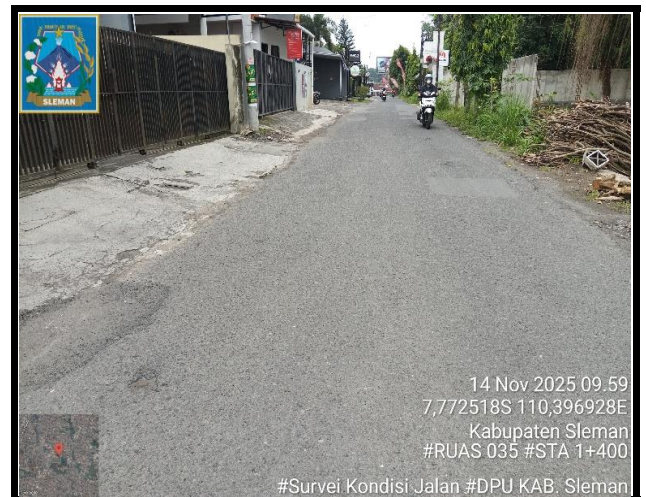
LOKASI :           **STA**                   **1+400**

KONDISI PERKERASAN :           **Sedang**  
LEBAR PERKERASAN :           4                   M  
TYPE PERKERASAN :           Aspal

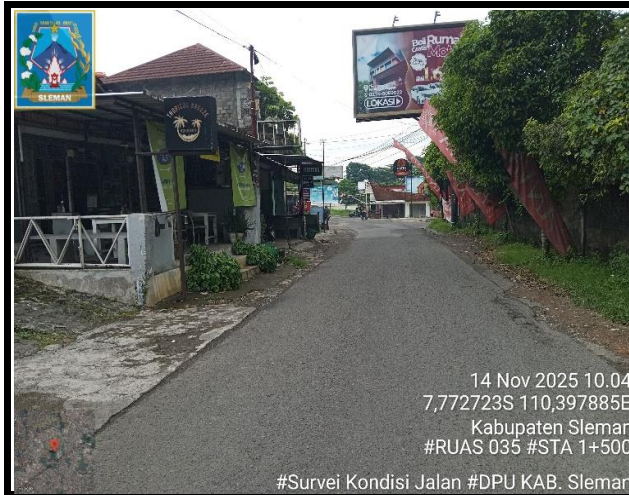
LOKASI :                **STA**                **1+500**

KONDISI PERKERASAN :                Sedang  
LEBAR PERKERASAN :                4                M  
TYPE PERKERASAN :                Aspal

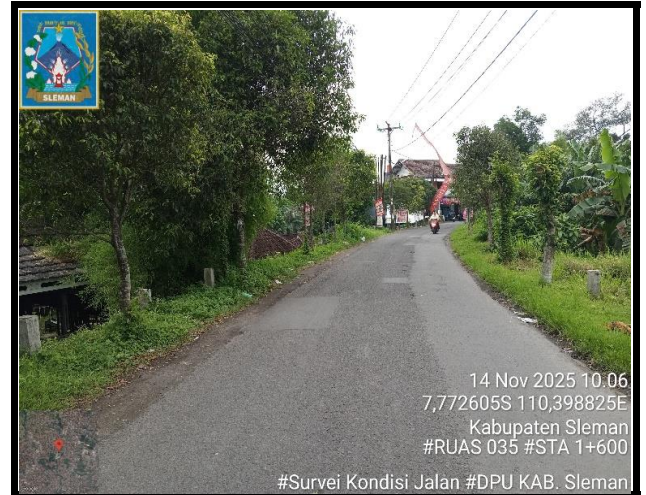
LOKASI :                **STA**                **1+600**

KONDISI PERKERASAN :                Sedang  
LEBAR PERKERASAN :                4                M  
TYPE PERKERASAN :                Aspal

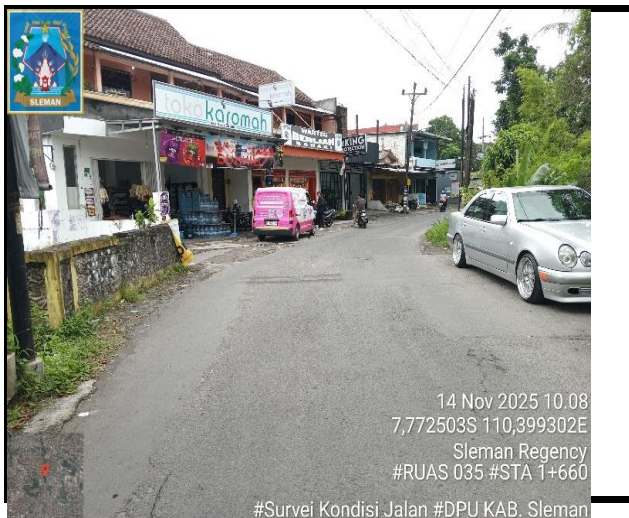
LOKASI :                **STA**                **1+660**

KONDISI PERKERASAN :                Sedang  
LEBAR PERKERASAN :                4,8                M  
TYPE PERKERASAN :                Aspal

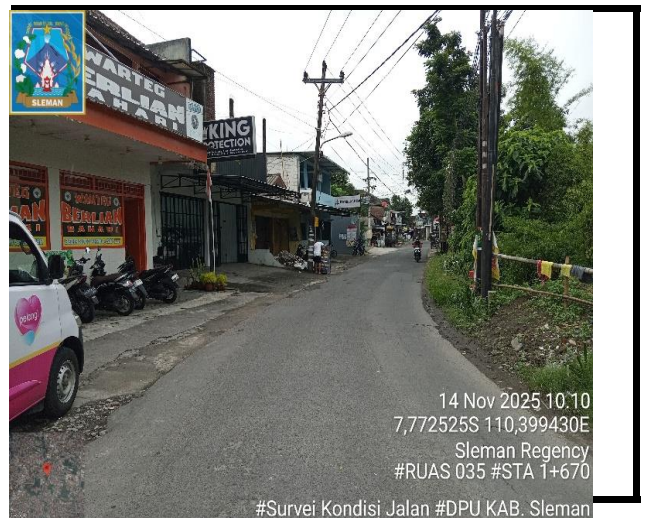
LOKASI :                **STA**                **1+670**

KONDISI PERKERASAN :                Sedang  
LEBAR PERKERASAN :                4                M  
TYPE PERKERASAN :                Aspal

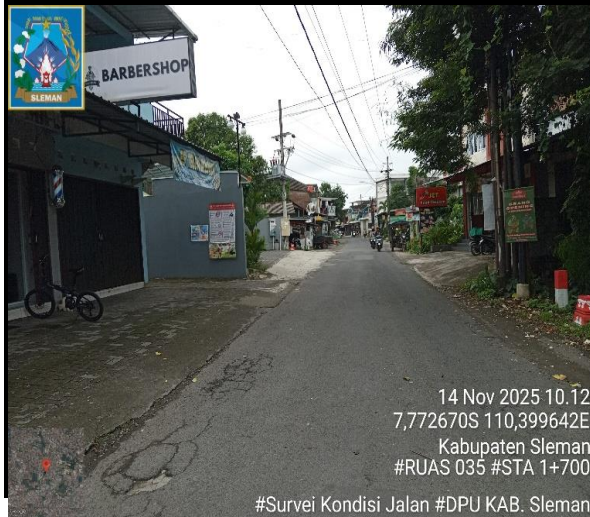
LOKASI : **STA 1+700**

KONDISI PERKERASAN : **Sedang**  
LEBAR PERKERASAN : 4 M  
TYPE PERKERASAN : Aspal

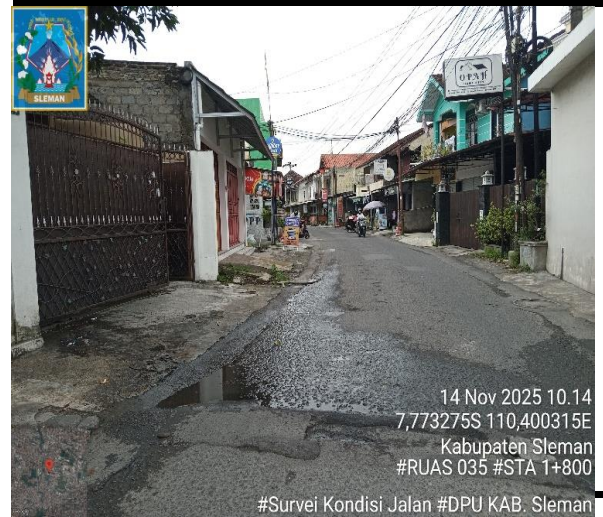
LOKASI : **STA 1+800**

KONDISI PERKERASAN : **Sedang**  
LEBAR PERKERASAN : 4 M  
TYPE PERKERASAN : Aspal

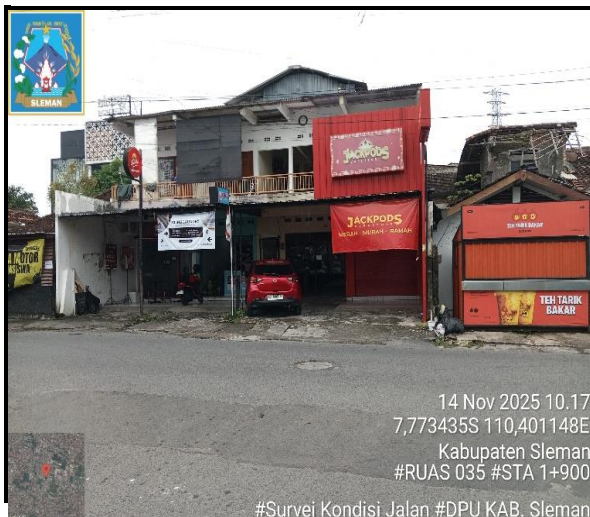
LOKASI : **STA 1+900**

KONDISI PERKERASAN : **Sedang**  
LEBAR PERKERASAN : 6,8 M  
TYPE PERKERASAN : Aspal

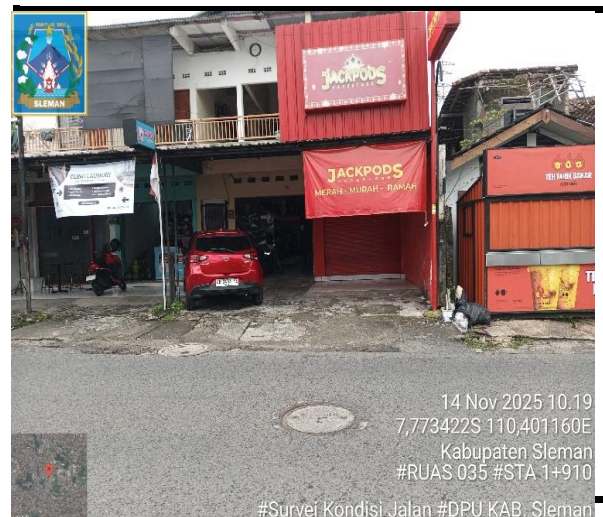
LOKASI : **STA 1+910**

KONDISI PERKERASAN : **Sedang**  
LEBAR PERKERASAN : 7,4 M  
TYPE PERKERASAN : Aspal
