## FOTO SURVEY KONDISI JALAN TAHUN 2025

**RUAS JALAN : Kadisono - Jurugan**

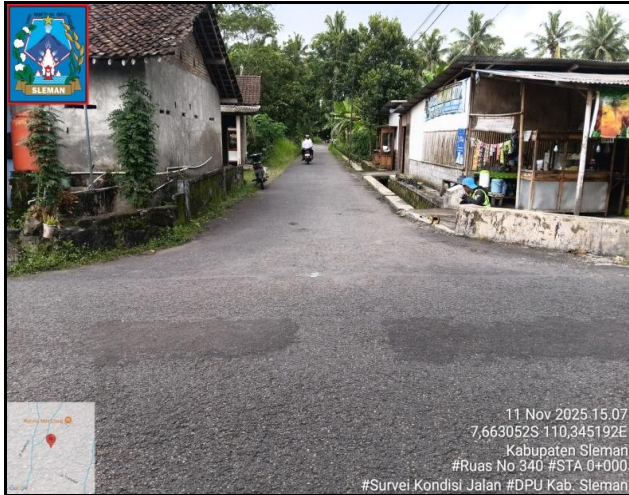
LOKASI : **STA 0+000**

KONDISI PERKERASAN : Rusak Ringan  
LEBAR PERKERASAN : 7.3 M  
TYPE PERKERASAN : Aspal

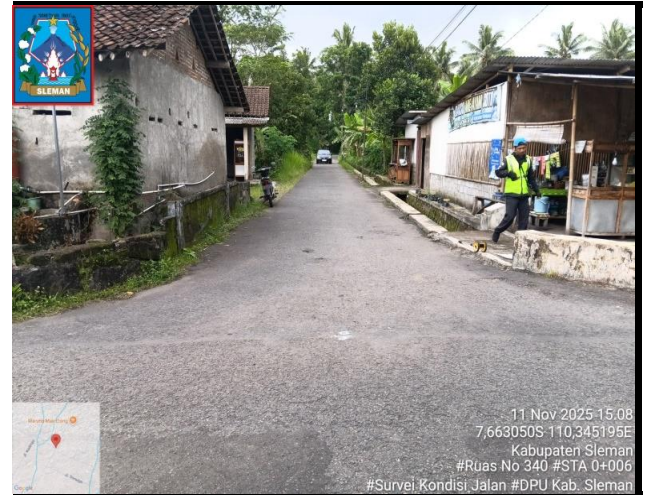
LOKASI : **STA 0+006**

KONDISI PERKERASAN : Rusak Ringan  
LEBAR PERKERASAN : 3.8 M  
TYPE PERKERASAN : Aspal

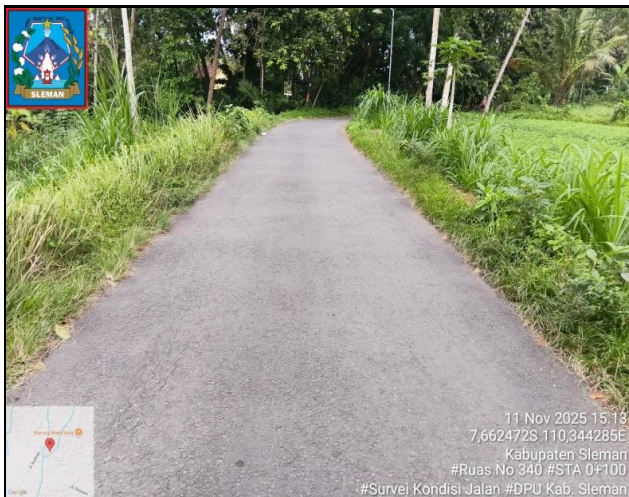
LOKASI : **STA 0+100**

KONDISI PERKERASAN : Rusak Ringan  
LEBAR PERKERASAN : 3.2 M  
TYPE PERKERASAN : Aspal

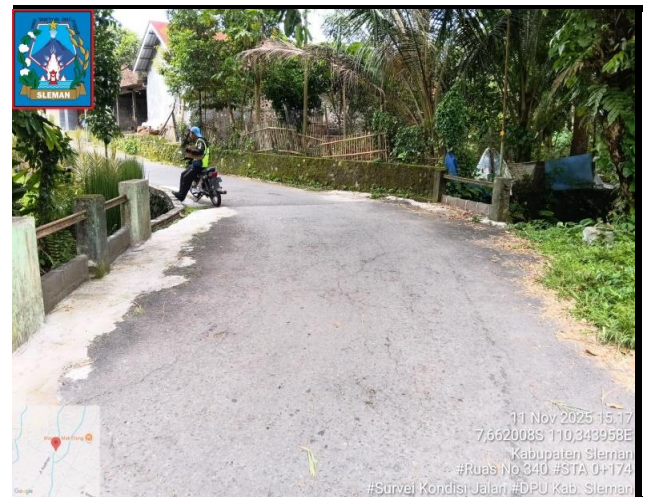
LOKASI : **STA 0+174**

KONDISI PERKERASAN : Rusak Ringan  
LEBAR PERKERASAN : 4.4 M  
TYPE PERKERASAN : Aspal

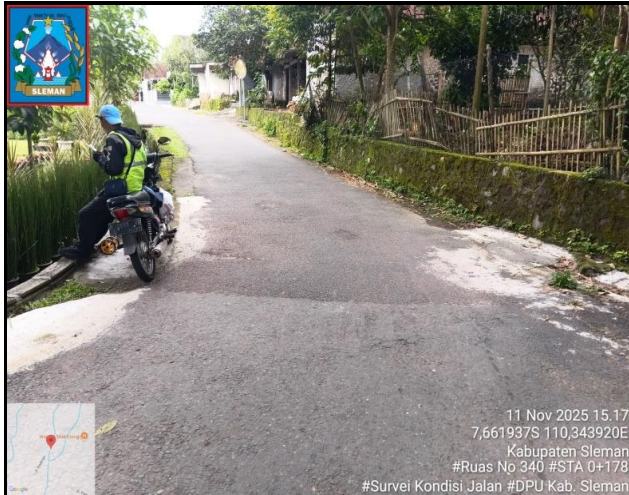
LOKASI : **STA 0+178**

KONDISI PERKERASAN : Rusak Ringan  
LEBAR PERKERASAN : 3.2 M  
TYPE PERKERASAN : Aspal

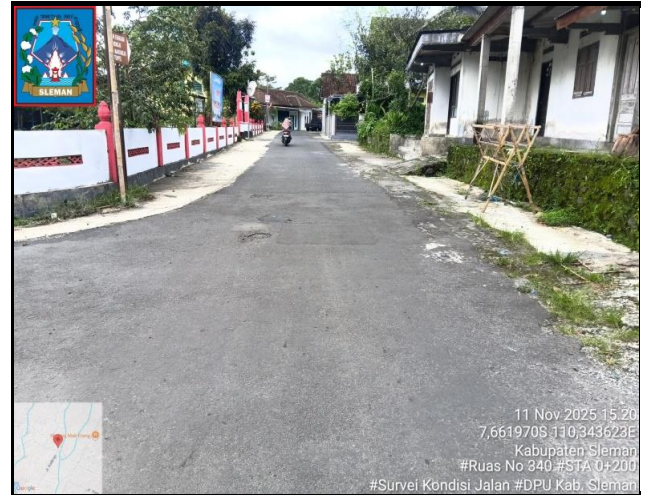
LOKASI : **STA 0+200**

KONDISI PERKERASAN : Rusak Ringan  
LEBAR PERKERASAN : 3.5 M  
TYPE PERKERASAN : Aspal

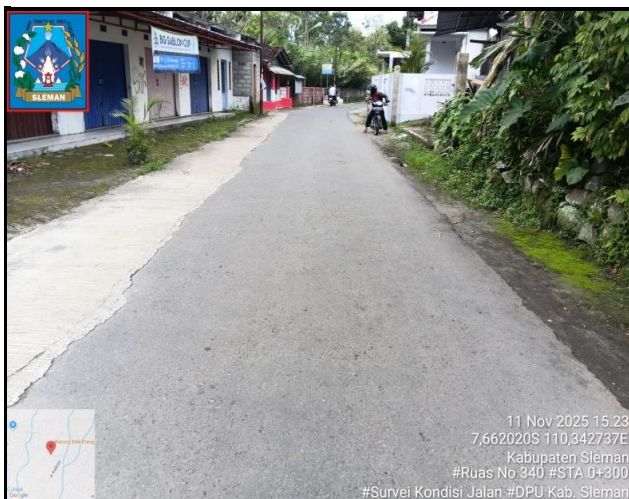
LOKASI : **STA 0+300**

KONDISI PERKERASAN : Sedang  
LEBAR PERKERASAN : 3.1 M  
TYPE PERKERASAN : Aspal

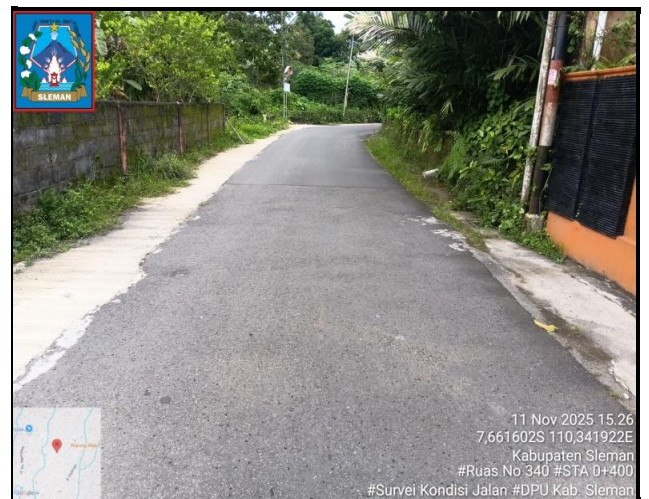
LOKASI : **STA 0+400**

KONDISI PERKERASAN : Sedang  
LEBAR PERKERASAN : 3.3 M  
TYPE PERKERASAN : Aspal

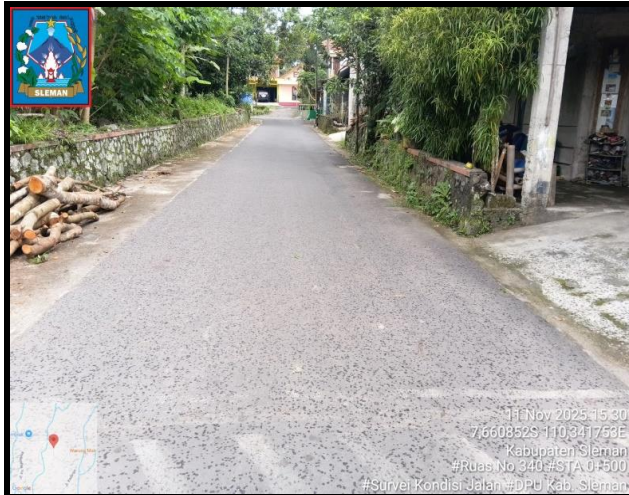
LOKASI :               **STA               0+500**

KONDISI PERKERASAN               :       Sedang  
LEBAR PERKERASAN               :       3.7               M  
TYPE PERKERASAN               :       Aspal

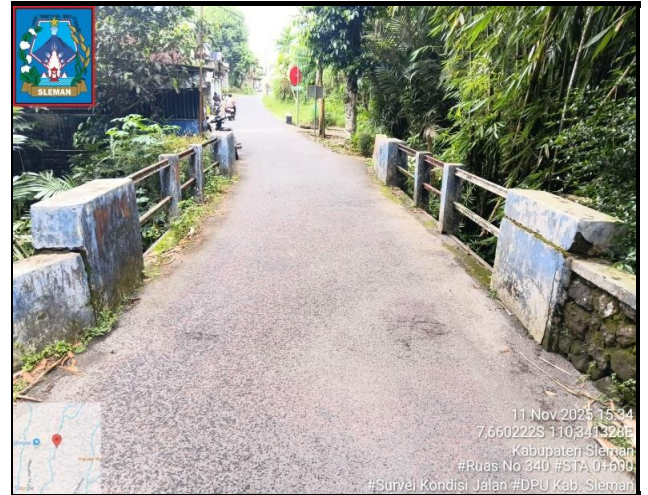
LOKASI :               **STA               0+600**

KONDISI PERKERASAN               :       Sedang  
LEBAR PERKERASAN               :       2.8               M  
TYPE PERKERASAN               :       Aspal

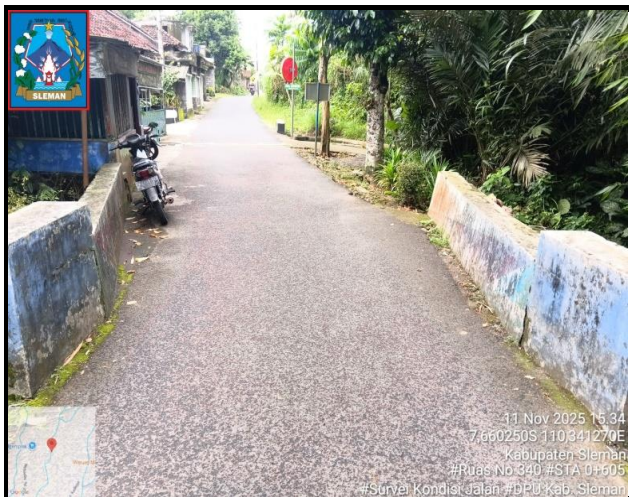
LOKASI :               **STA               0+605**

KONDISI PERKERASAN               :       Sedang  
LEBAR PERKERASAN               :       3.6               M  
TYPE PERKERASAN               :       Aspal

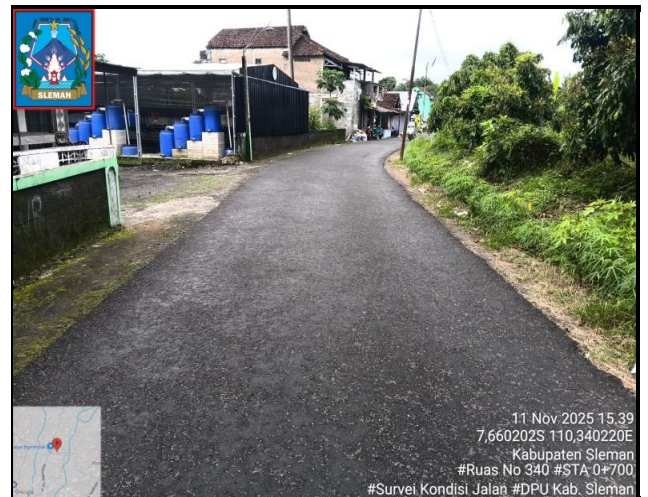
LOKASI :               **STA               0+700**

KONDISI PERKERASAN               :       Sedang  
LEBAR PERKERASAN               :       3.6               M  
TYPE PERKERASAN               :       Aspal

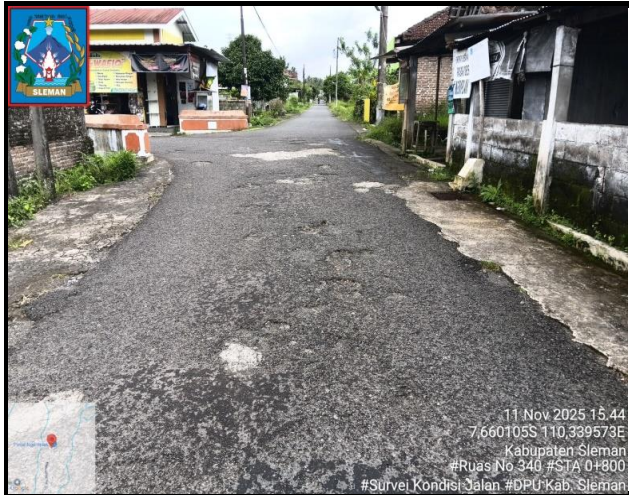
LOKASI :               **STA               0+800**

KONDISI PERKERASAN               :       Rusak Ringan

LEBAR PERKERASAN               :       3.6               M

TYPE PERKERASAN               :       Aspal

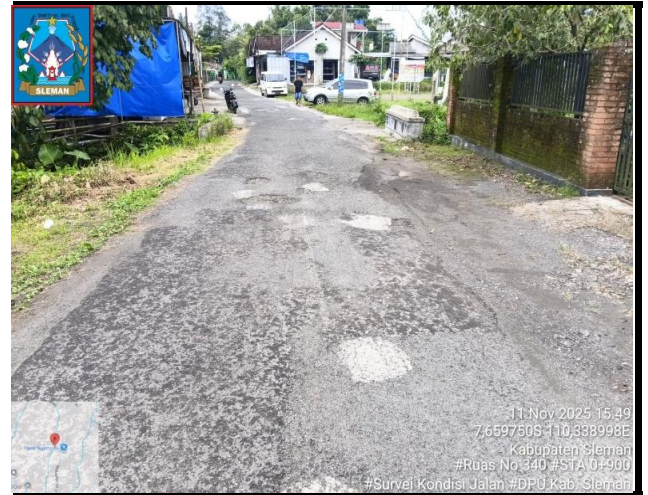
LOKASI :               **STA               0+900**

KONDISI PERKERASAN               :       Rusak Ringan

LEBAR PERKERASAN               :       3.5               M

TYPE PERKERASAN               :       Aspal

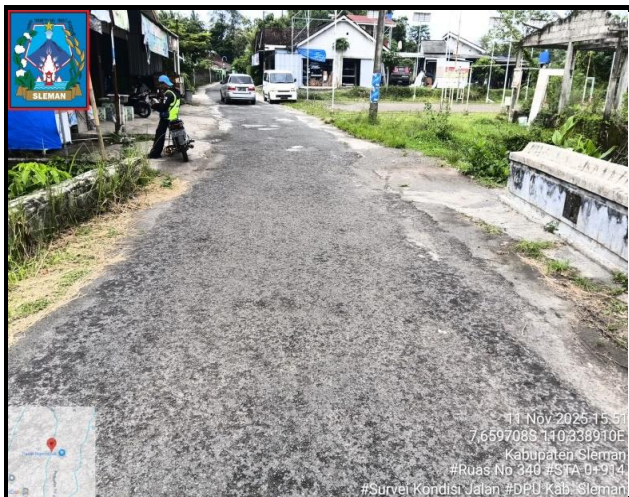
LOKASI :               **STA               0+914**

KONDISI PERKERASAN               :       Rusak Ringan

LEBAR PERKERASAN               :       3.3               M

TYPE PERKERASAN               :       Aspal

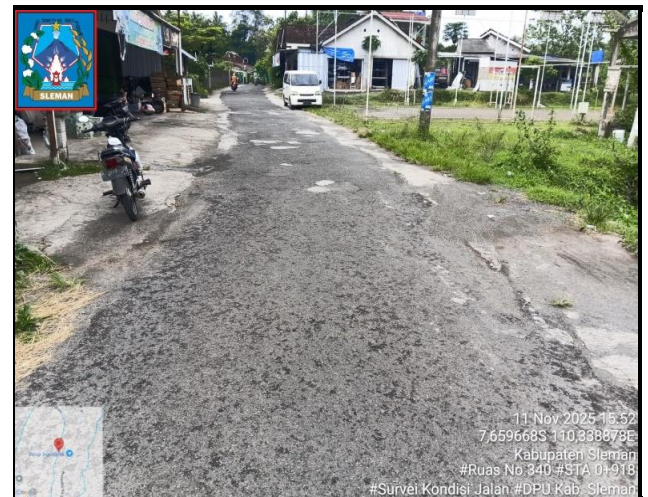
LOKASI :               **STA               0+918**

KONDISI PERKERASAN               :       Rusak Ringan

LEBAR PERKERASAN               :       3.5               M

TYPE PERKERASAN               :       Aspal

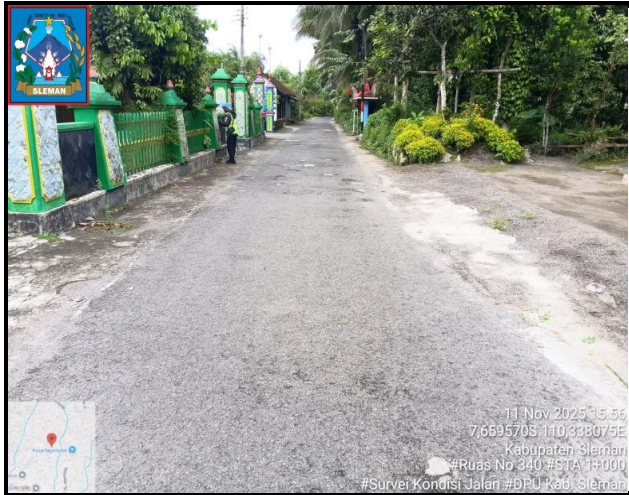
LOKASI :               **STA               1+000**

KONDISI PERKERASAN :       Rusak Ringan  
LEBAR PERKERASAN :       3.5               M  
TYPE PERKERASAN :       Aspal

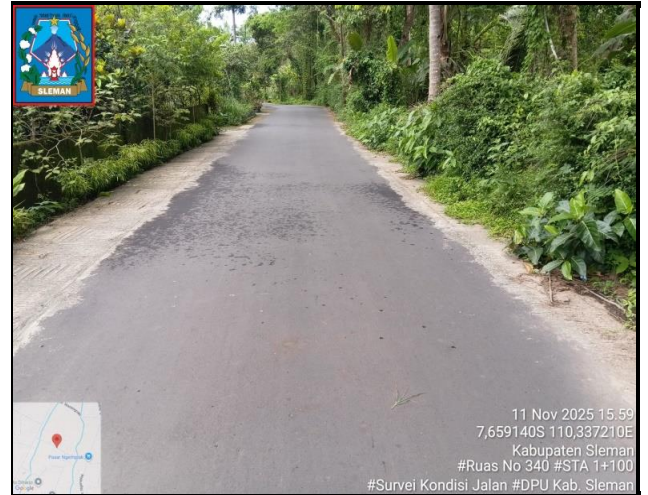
LOKASI :               **STA               1+100**

KONDISI PERKERASAN :       Baik  
LEBAR PERKERASAN :       3.8               M  
TYPE PERKERASAN :       Aspal

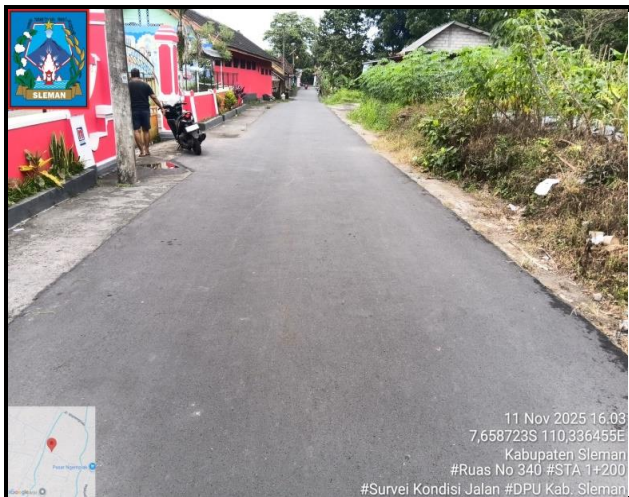
LOKASI :               **STA               1+200**

KONDISI PERKERASAN :       Baik  
LEBAR PERKERASAN :       3.8               M  
TYPE PERKERASAN :       Aspal

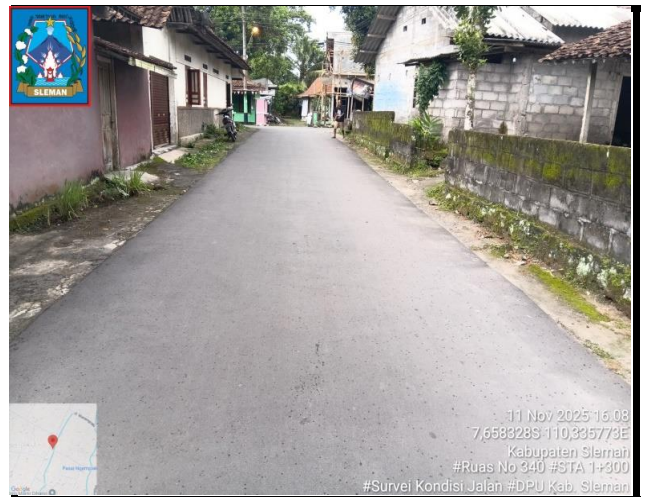
LOKASI :               **STA               1+300**

KONDISI PERKERASAN :       Baik  
LEBAR PERKERASAN :       3.8               M  
TYPE PERKERASAN :       Aspal

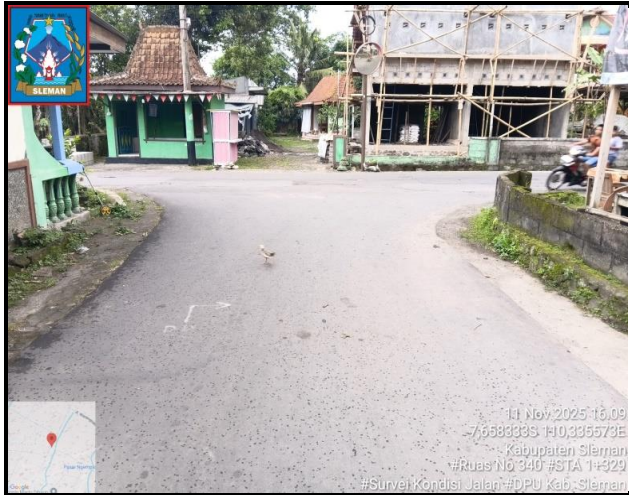
LOKASI :               **STA               1+329**

KONDISI PERKERASAN               :       Baik  
LEBAR PERKERASAN               :       5.8               M  
TYPE PERKERASAN               :       Aspal

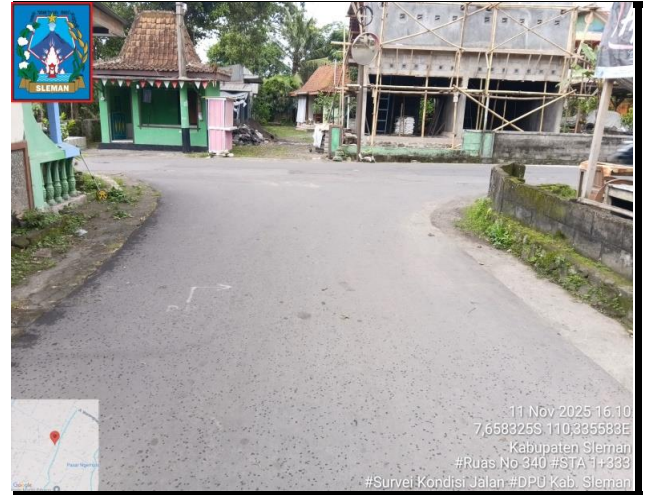
LOKASI :               **STA               1+333**

KONDISI PERKERASAN               :       Baik  
LEBAR PERKERASAN               :       9.8               M  
TYPE PERKERASAN               :       Aspal

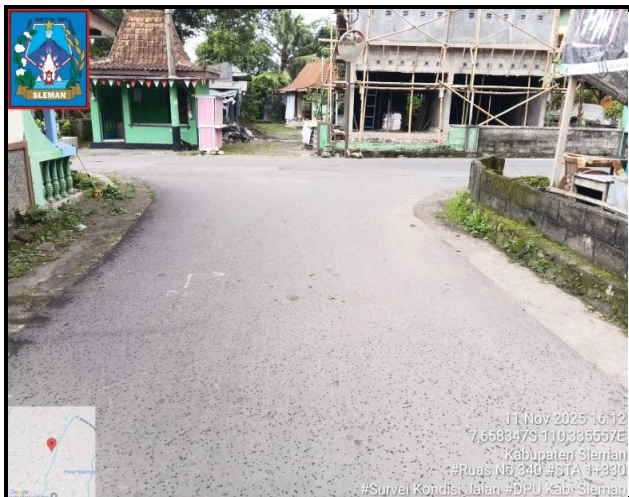
LOKASI :               **STA               1+330**

KONDISI PERKERASAN               :       Baik  
LEBAR PERKERASAN               :       9.8               M  
TYPE PERKERASAN               :       Aspal
